# Manhole Inspection Summary

Manhole # S43GG\_050MH

**Inspection** ☐ Is Incomplete Rating: **3) Fair**

Insp Date: **3/22/10 11:11 AM**

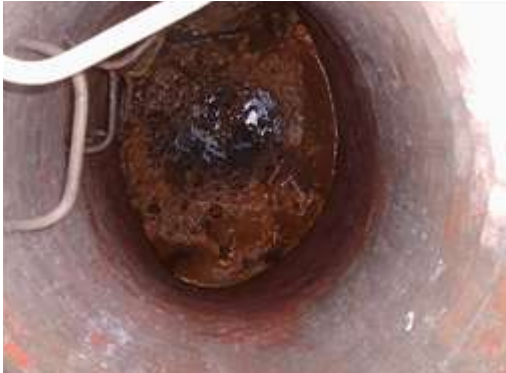
Top View

Active surcharge.

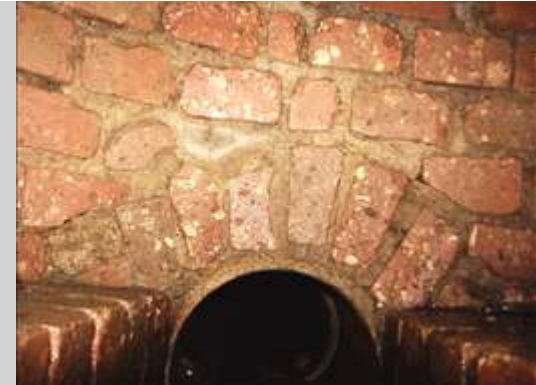
8 in. Circular Gravity Sewer  
Pipe Out @ 12 O'Clock

Pipe Height: **12** (in.) Rod and Bar (Angled)  
Pipe Material: **Clay** ☐ Pipe Lined  
Invert Depth: **12.25** (ft.) Flow Characteristics: **Fast**  
Deposits: ☒ None ☐ Mud ☐ Gravy ☐ Debris ☐ Grease  
Silt Depth: (in.) Deposits Extent:  
Infiltration: **None** Pipe Seal Cond: **Sound**

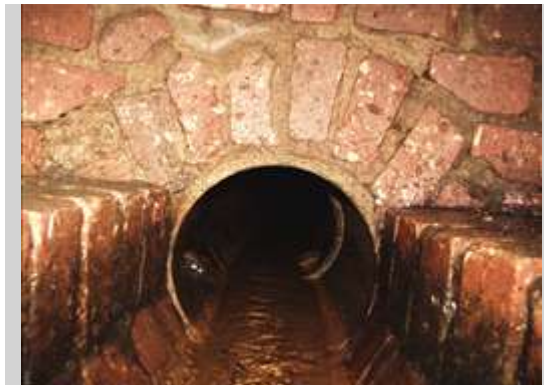
6 O'Clock Inflow  
Pipe In @ 6 O'Clock

Pipe Height: **12** (in.) Rod and Bar (Angled)  
Pipe Material: **Clay** ☐ Pipe Lined  
Invert Depth: **12.17** (ft.) Flow Characteristics: **Slow**  
Deposits: ☐ None ☒ Mud ☒ Gravy ☒ Debris ☐ Grease  
Silt Depth: **4** (in.) Deposits Extent: **Medium**  
Infiltration: **None** Pipe Seal Cond: **Sound**
